Final Technical Report - EGC

Project
European Green Cities

Title of project: European Green Cities - European - Global Renewable Energy and Environmentally Responsible Neighbourhoods and Cities

3 CONSTRUCTION, INSTALLATION AND COMMISSIONING

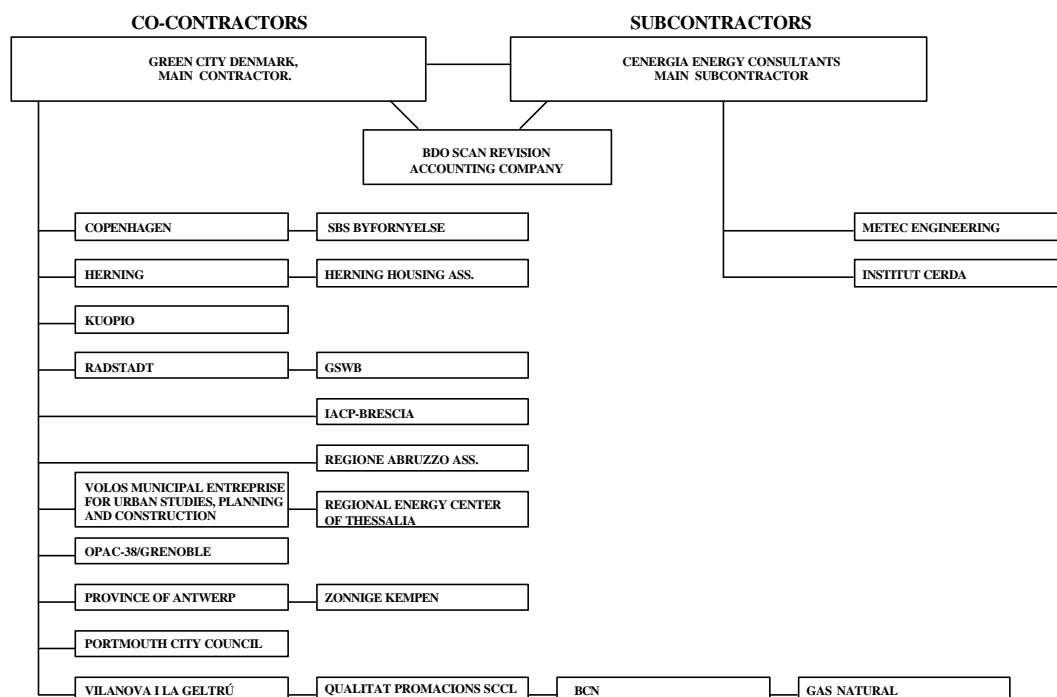
Figure 3.1

EUROPEAN GREEN CITIES - MANAGEMENT STRUCTURE

ALL CONTRACTORS AND SUBCONTRACTORS ARE MEMBERS OF THE STEERING COMMITTEE OF THE TARGET PROJECT.
MANAGEMENT TEAM: GREEN CITY DENMARK, CENERGIA ENERGY CONSULTANTS, METEC ENGINEERING, INSTITUT CERDÁ.

After consultations with the European Commission a management structure as described in figure 3.5.1. was agreed. This means that the involved cities and builders were all contractors with Green City Denmark as coordinator.

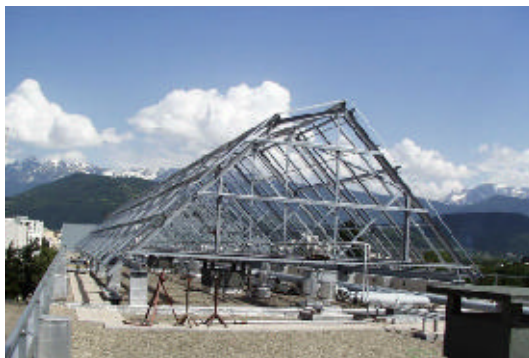
The most important difficulty encountered has concerned the floor of the flat roof, which was too weak to sustain the thermal solar panels. The solution adopted was to realise a ridge roof on the part of the buildings where the thermal solar panels are to be installed. The structure of this ridge roof is shown on the photo below.

Figure 3.1: Photo of the project - Surieux. View from the ridge roof.

The floor of the flat roof is too weak to sustain the thermal solar panels. Another way to fix them was to be found.
