## **Renovations of multi-story buildings and establishment of new apartments in the attics**

**Mónika Tornóczky**  
**VELUX Hungary**

**Panel building in Budapest**  
**Pilot project in St. Petersburg**  
**Loft conversions in old buildings**

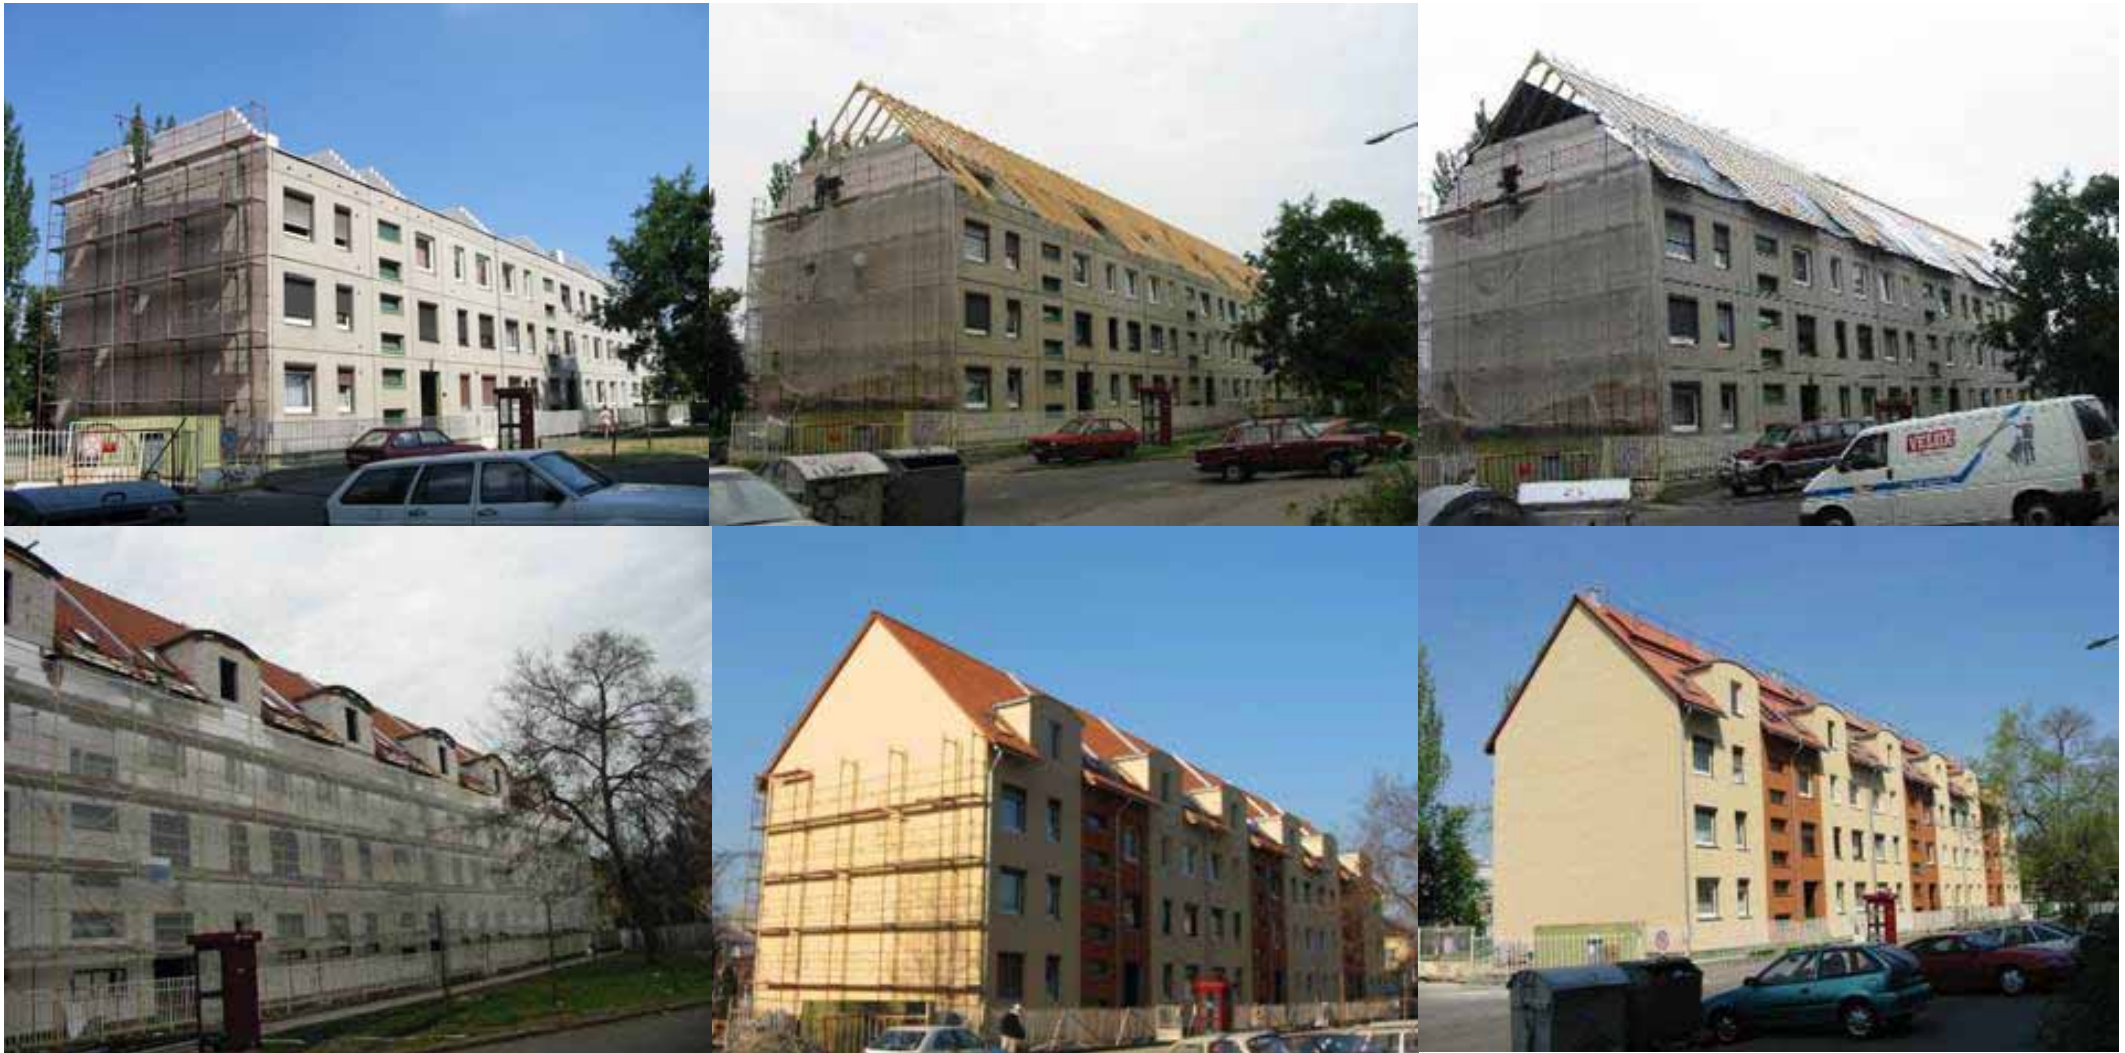
The changes on the street facade.

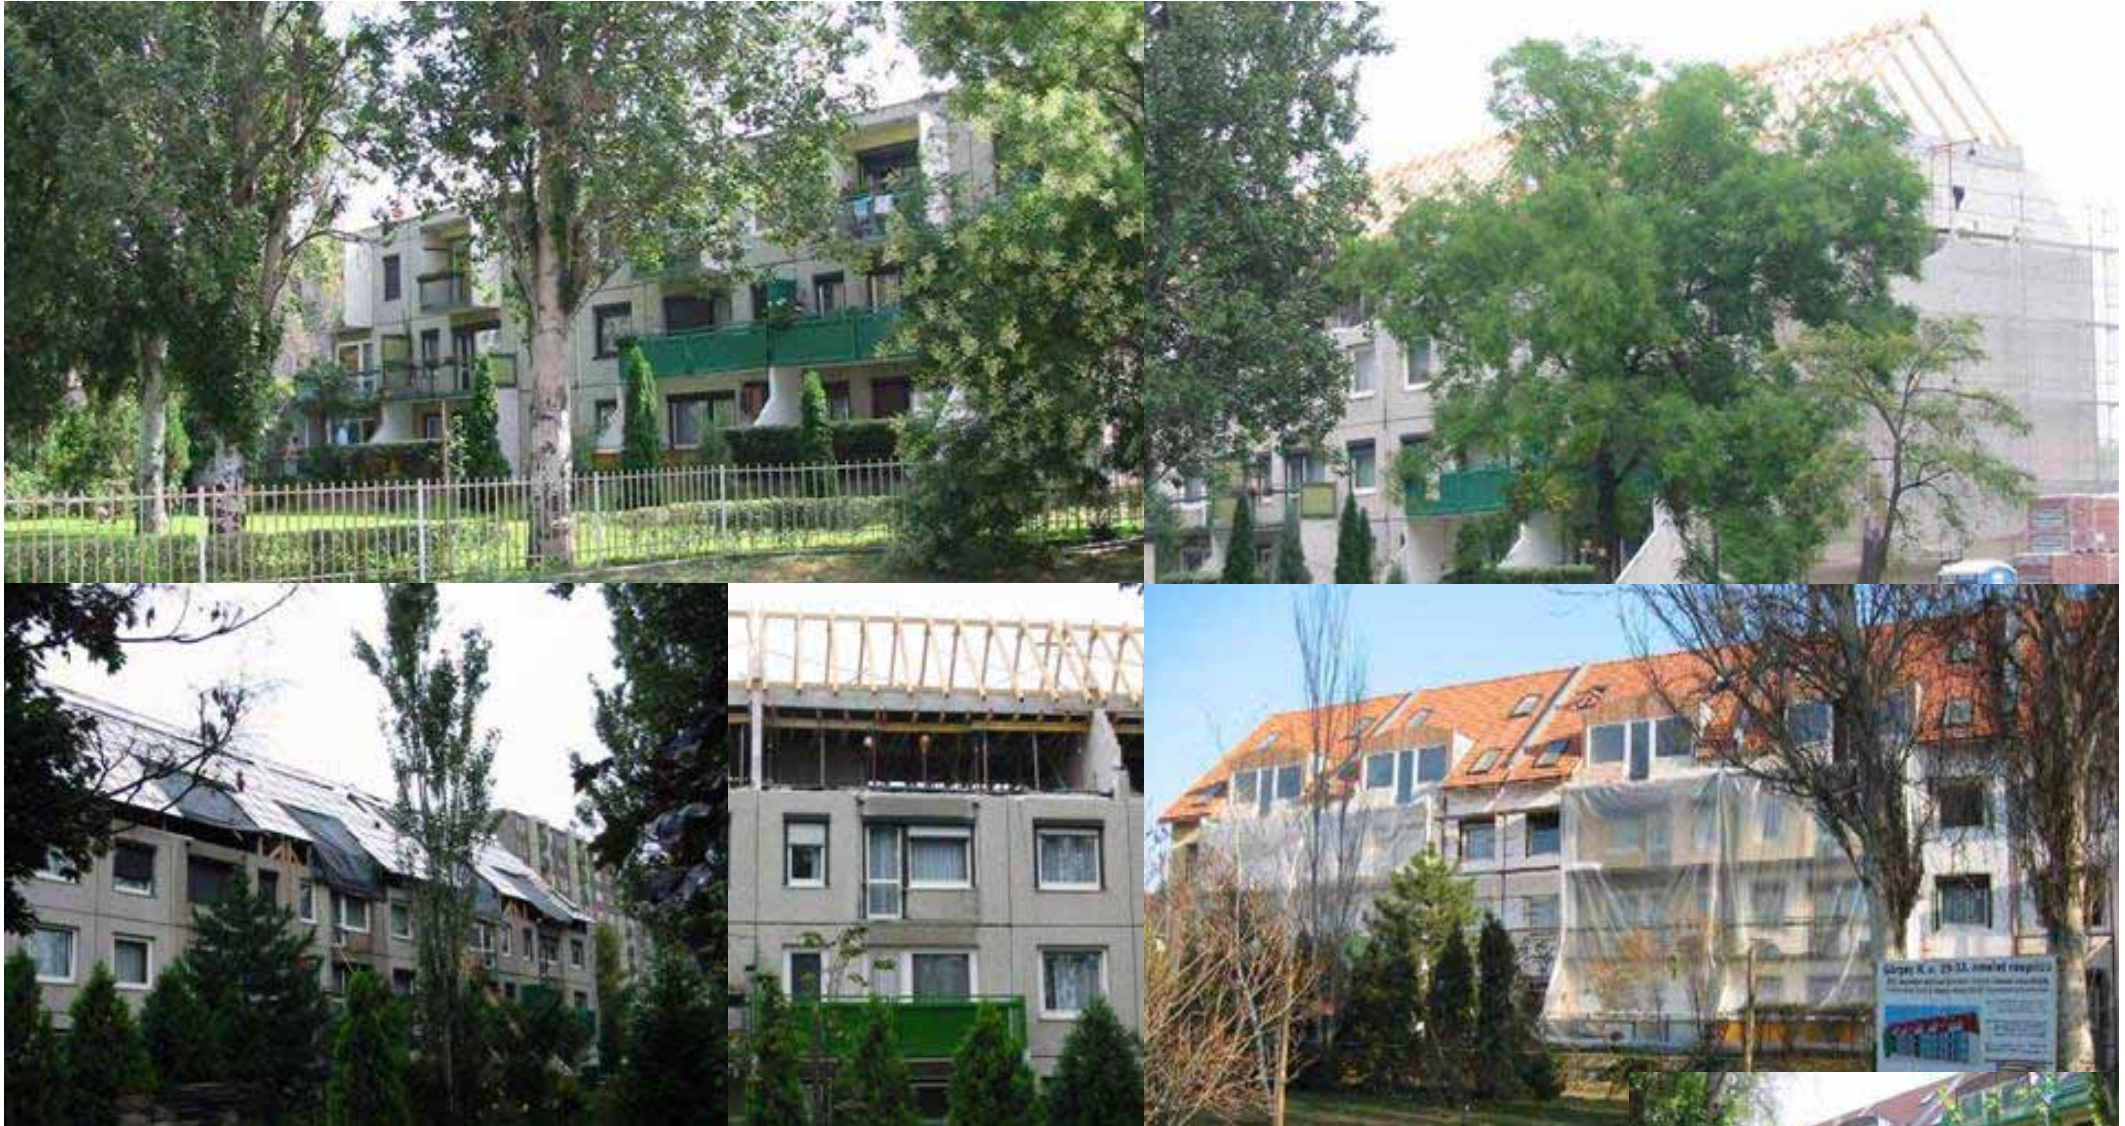
Changes on the facade facing the garden.

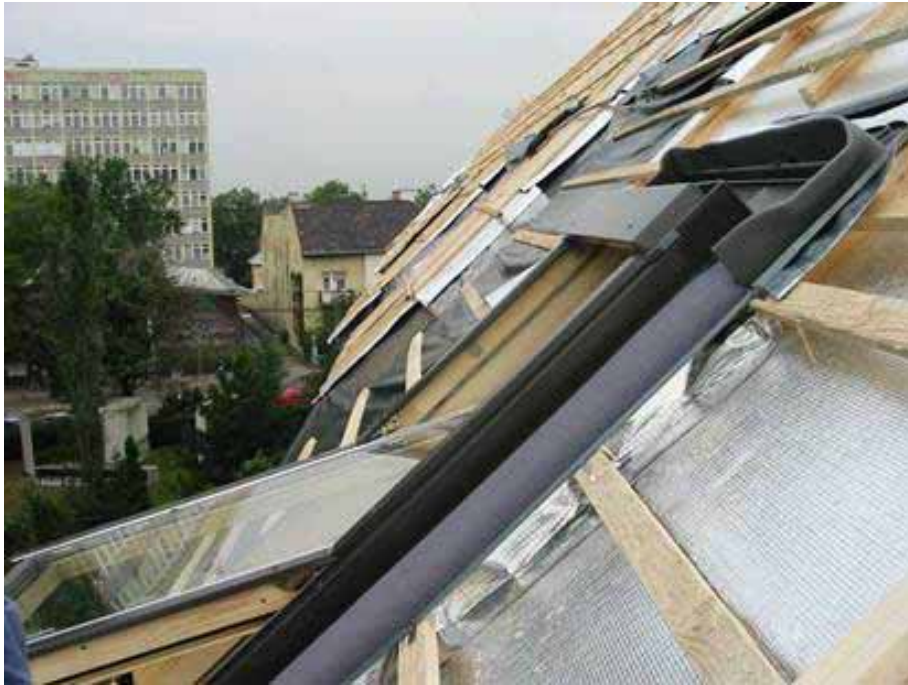
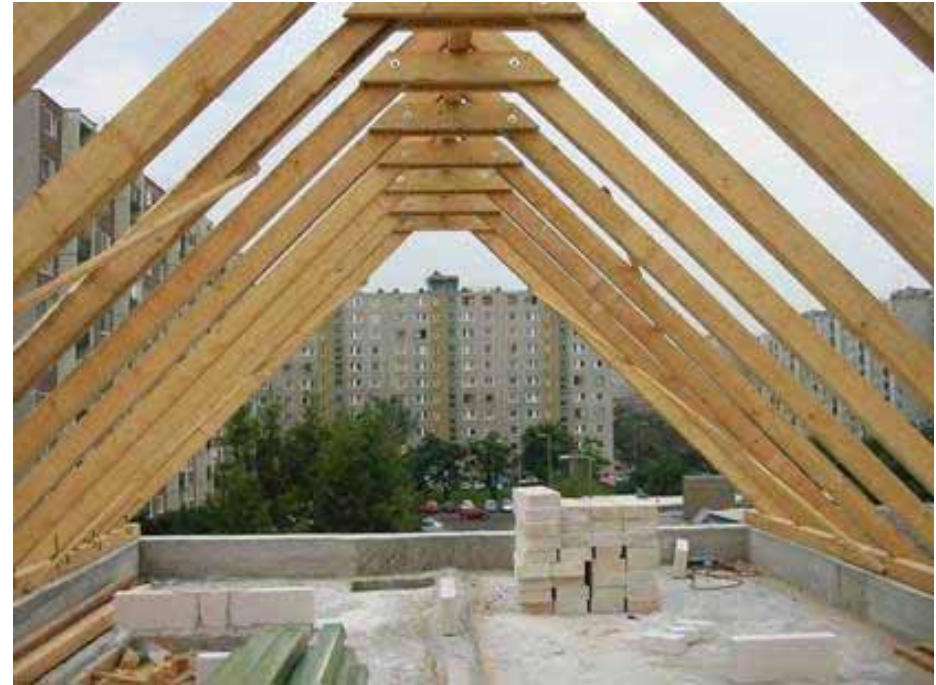
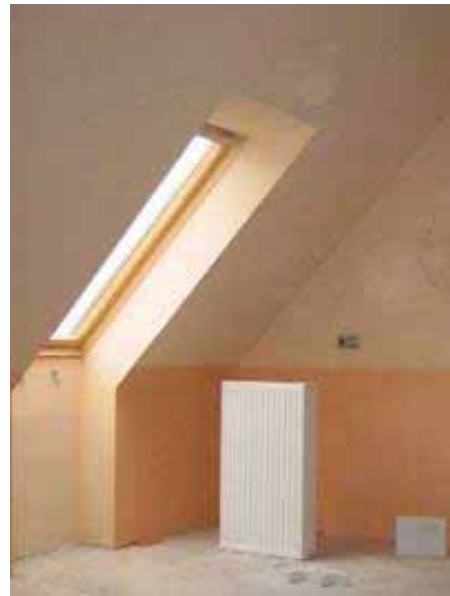
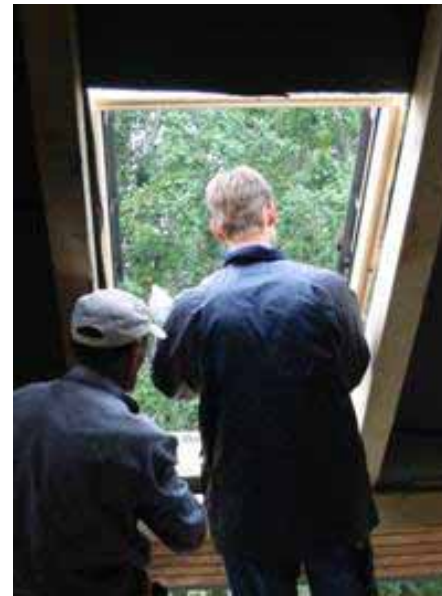
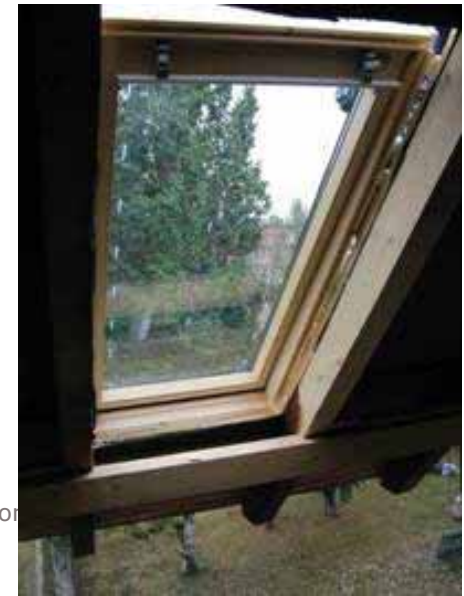
Attic construction.

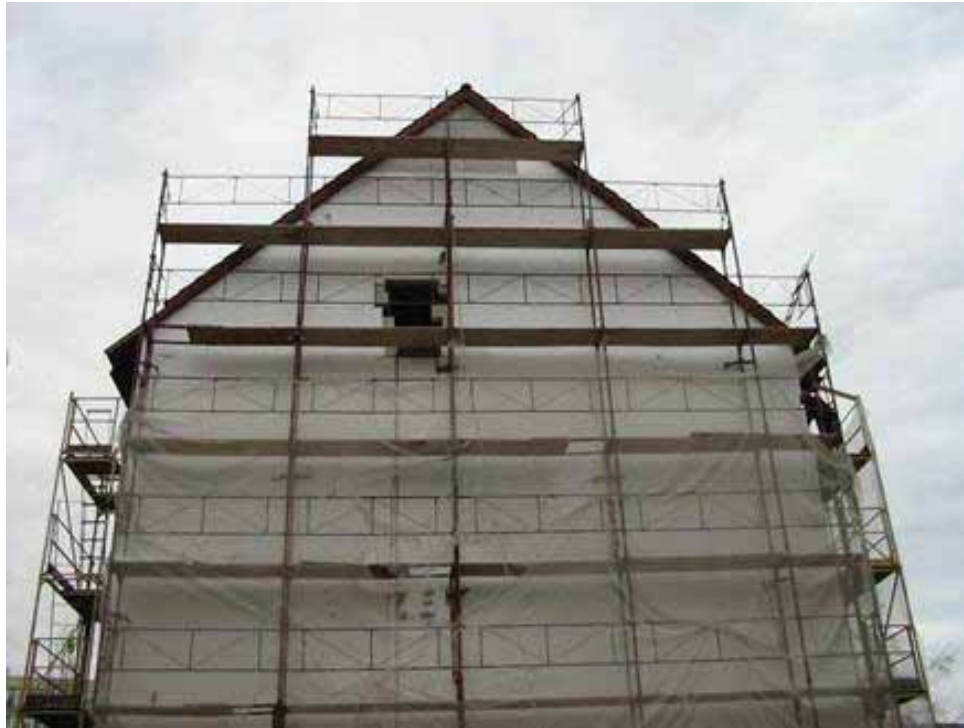
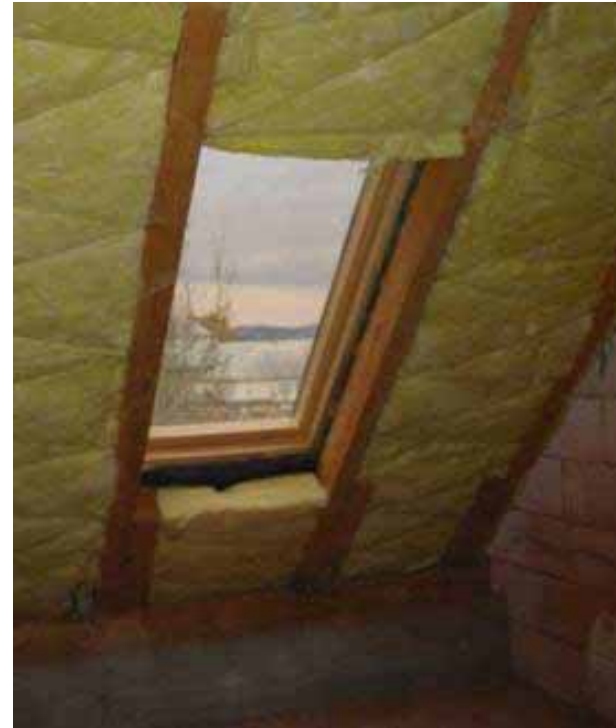
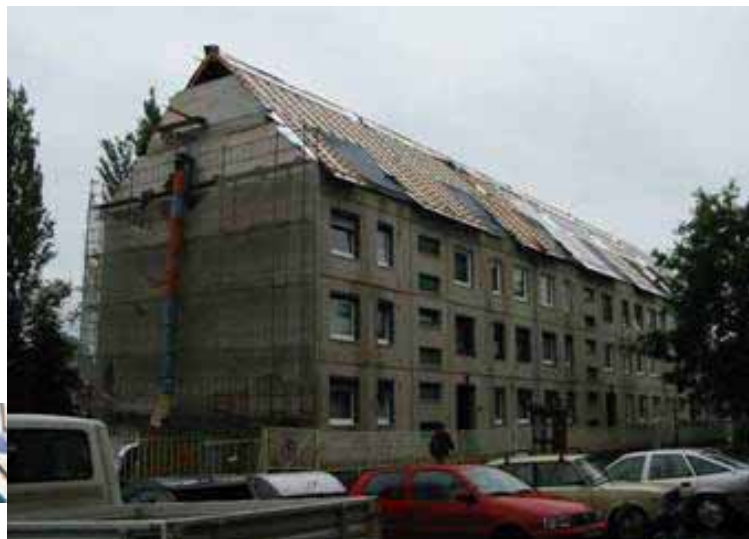
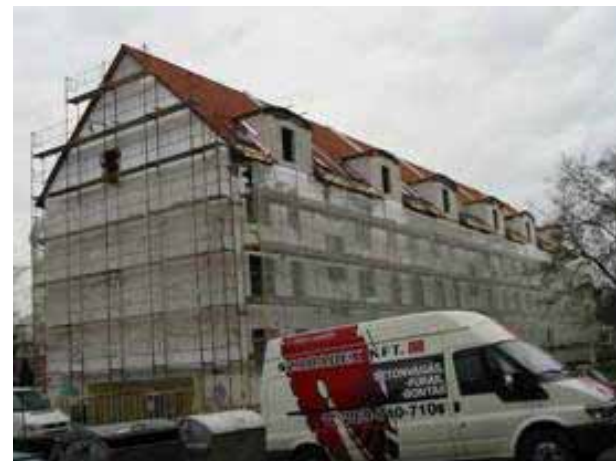
Placing the insulation.

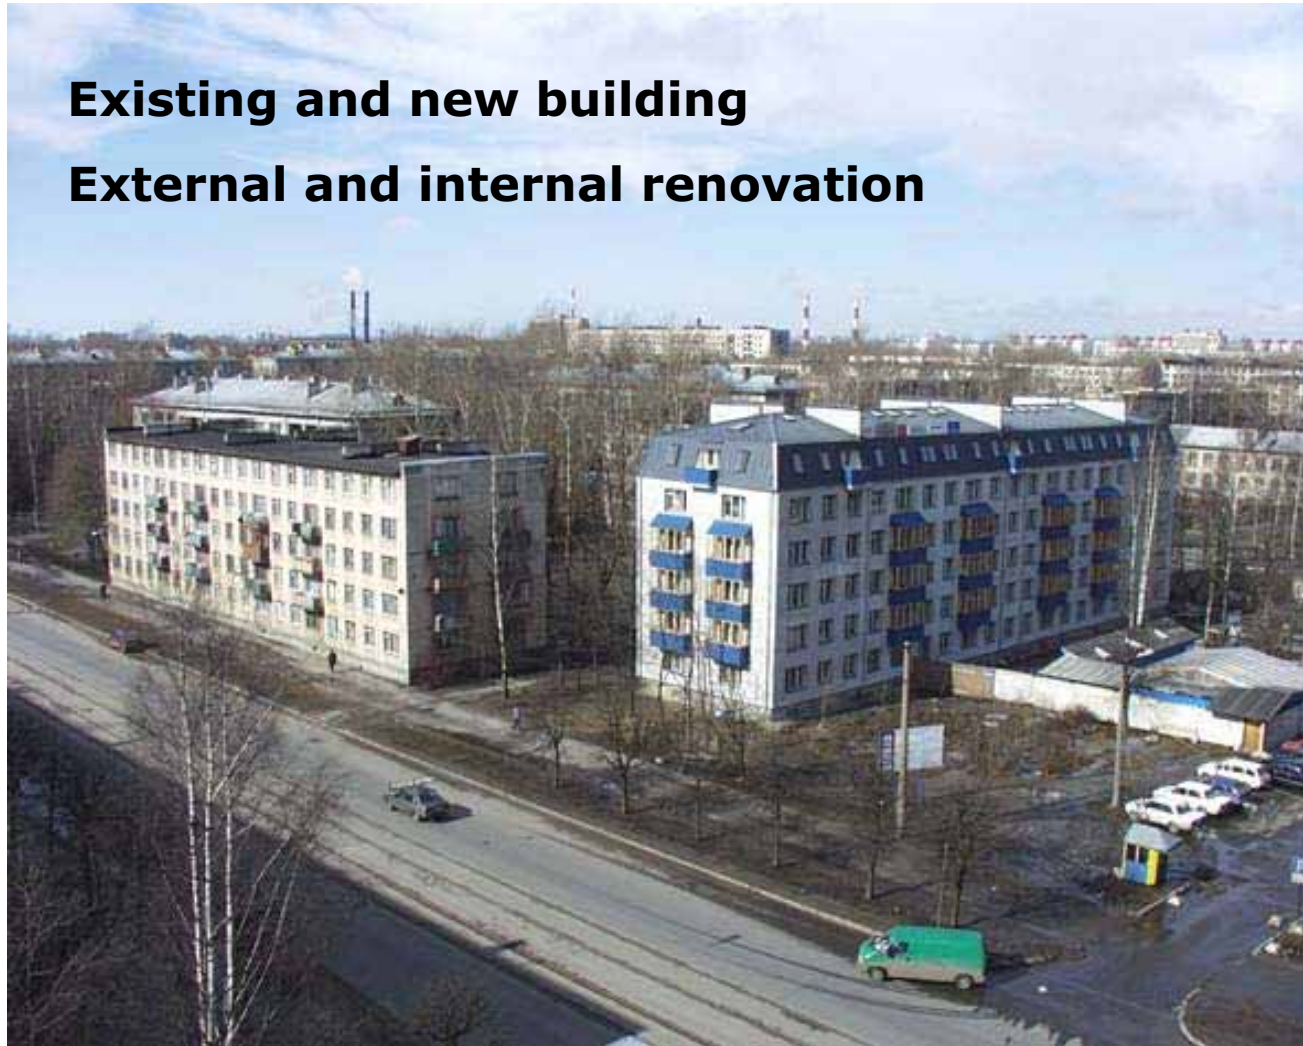
**Existing and new building**  
**External and internal renovation**

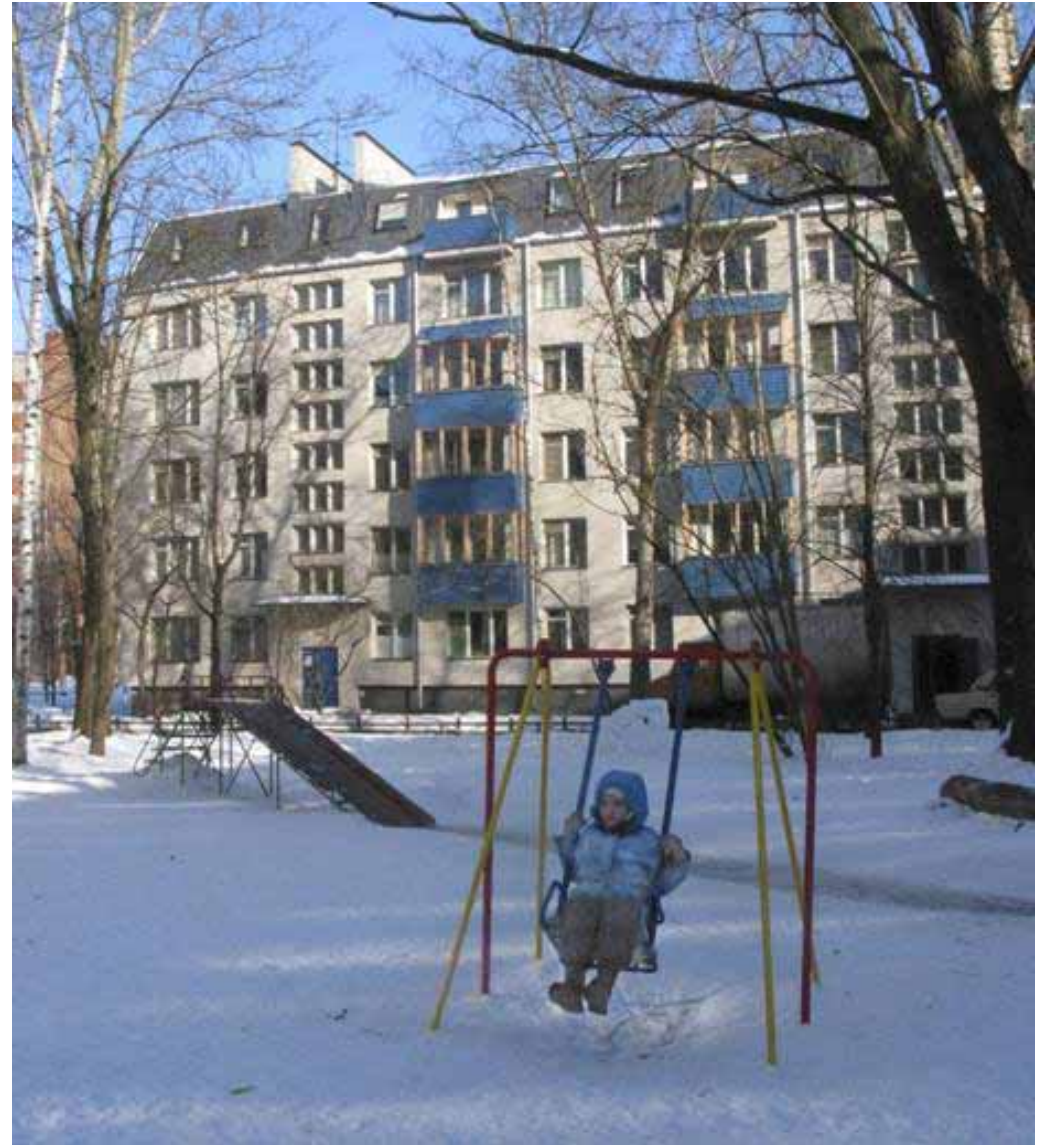
- **New attic**
- **Heating and water supply lines renovated**
- **New heating center and water gauge unit**
- **Heating and water meters installed**
- **Thermostats installed in each apartment**
- **Facade and staircases renovated**
- **Existing balconies renovated**
- **Windows renovated**
- **Door phones installed**
- **Surrounding area renovated**
