EUROPEAN GREEN CITIES NETWORK

GREEN BUILD TOOL

Urban District Analipsi Volos – Greece

**VOLOS MUNICIPAL ENTERPRISE
FOR URBAN STUDIES CONSTRUCTION
& DEVELOPMENT**

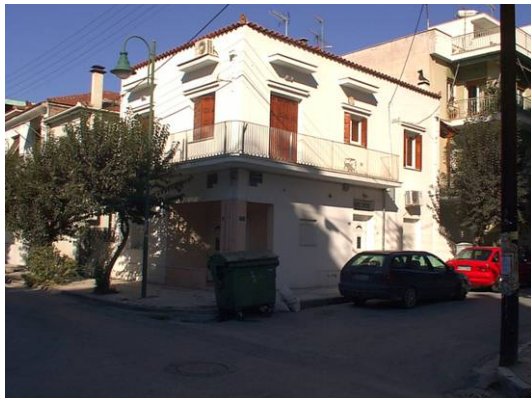
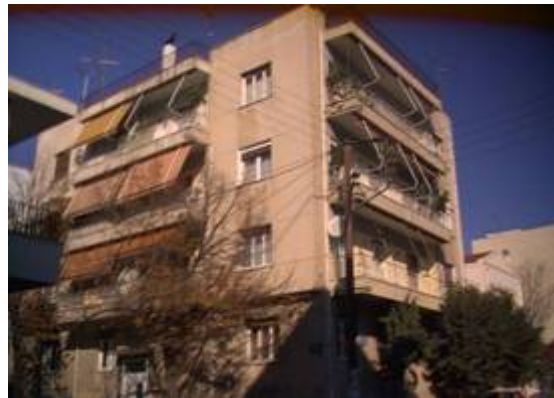
In this district, as a majority, stand new erected blocks of flats with many storeys. You can also see older buildings of one or two storeys. Intense building activity, regarding the construction of blocks of flats, is observed. Free downstairs for car parking exists mainly in flat blocks of the interior of the case study area, which is dominated by new buildings.

There are pavements of big width and rows of trees on all streets. Street sides are dominated by a big number of parked cars. Clear plot spaces there are in the backyards of the buildings.

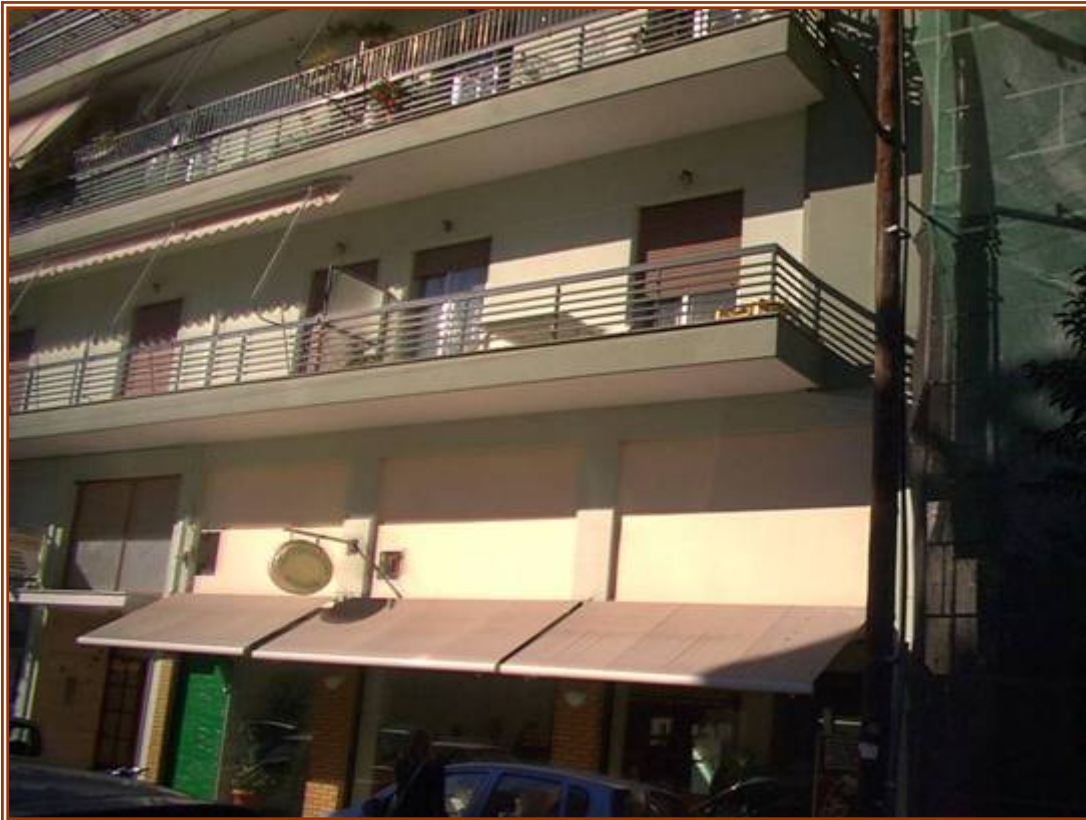
3.1 Building no 1

This is a 4 storey building with shops in the ground floor. It consists of 24 apartments that vary in size (from a studio of 25m² to a big apartment of 125m²). As a total 45 people live in this block of flats. The building was constructed on 1981.

The fuel used for heating is oil and the mean yearly consumption is between 17 and 19 tons, depending on the severity of the winter. The oil burner is being cleared twice per year, while every year on October it is being maintained. This building is not supplied with natural gas. For heating water they use electric water heaters.

Cooling of the flats is obtained with air conditioners. Indeed we have a big percentage of air conditioners per apartment in this block of flats (62,50%). Good lighting conditions are secured by the orientation of the building (Eastwards) and the big casements on this forefront. Most balconies are covered by awnings, which protect during hot summer periods. There is a flat roof and the dominant materials of the building are cement and aluminium.

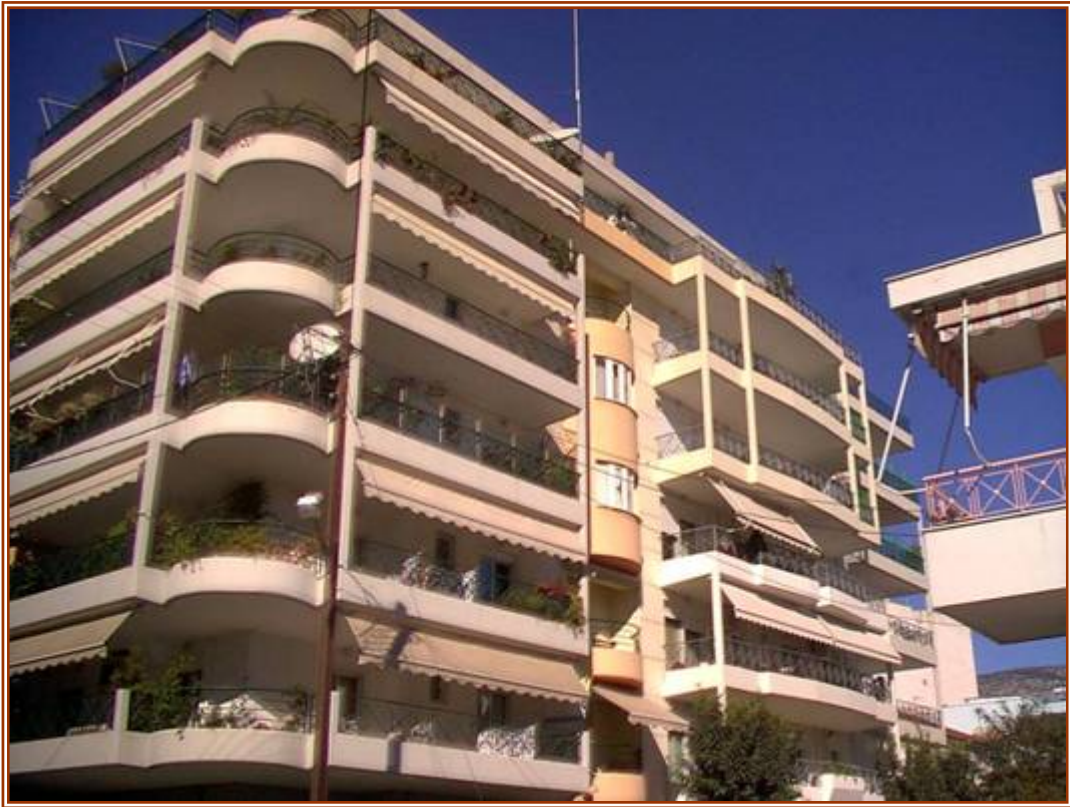
3.2. Building No2

This is a 6 storey building. It consists of 25 apartments that vary in size (from a studio of 30m² to a big apartment of 115m²). As a total 75 people live in this block of flats. The building was constructed on 1997, and this is evident by its outer sight as well as by its inner arrangements.

The fuel used for heating is oil and the mean yearly consumption is 17 tons. The oil burner is being cleared and maintained every year, on May. There is a supply of natural gas but flats have just begun to use it. Moreover, 18 apartments spare a fireplace. A boiler system is heating water. Overall, these installations have resulted to a relatively low rate of oil consumption, 7,8 lit/m²/year.

In many apartments cooling is obtained with air conditioners. We have a medium percentage of air conditioners per apartment in this block of flats (48%). Good lighting conditions are secured by the orientation of the building (Eastwards – Westwards – Southwards). Most balconies are covered by awnings, which protect during hot summer periods. There is a flat roof and the dominant materials of the building are cement and aluminium.

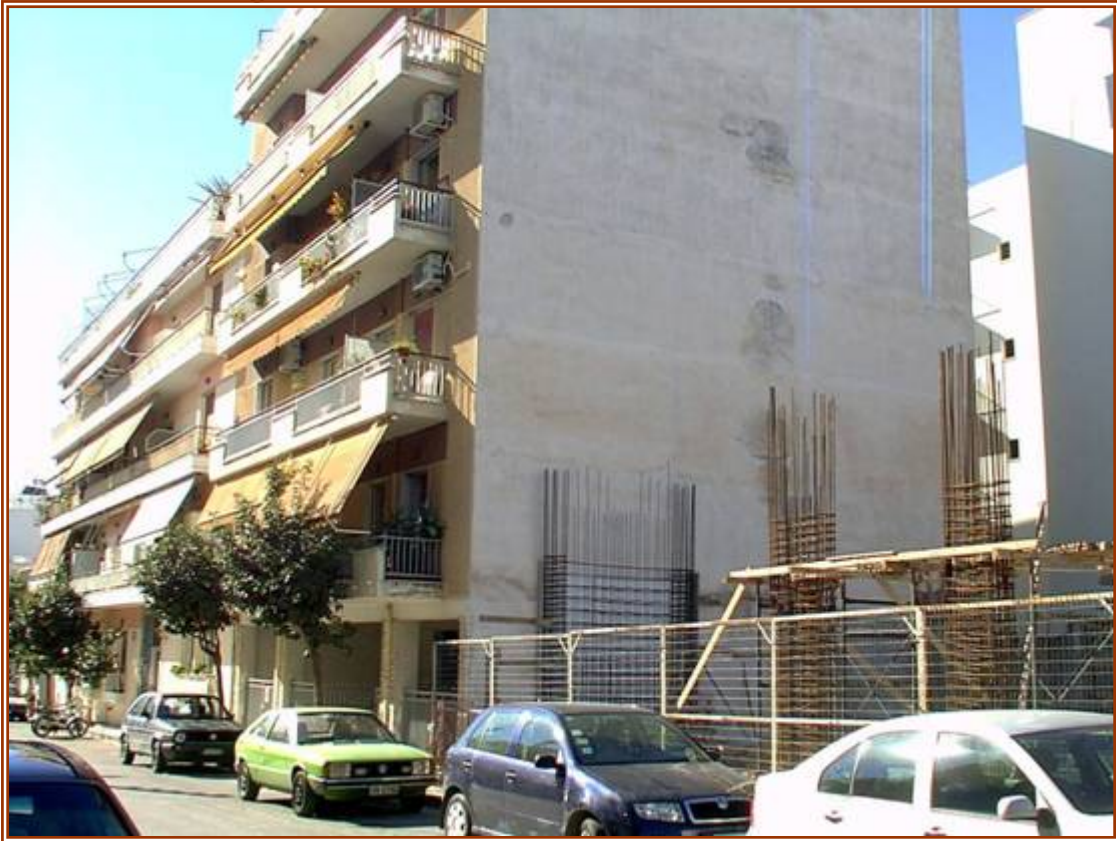
3.3. Building No3

This is a 5 storey stilted building. It consists of 10 apartments that vary in size (from a studio of 30m² to a big apartment of 159m²). As a total 30 people live in this block of flats. The building was constructed on 1980.

The fuel used for heating is oil and the mean yearly consumption is between 6 and 7 tons, which means we have a consumption rate of 7,8 lit/m²/year. The oil burner is being maintained every year, on September. This building is not supplied with natural gas. For heating water they use electric water heaters, while there is only 1 solar water heater.

In some apartments cooling is obtained with air conditioners. Good lighting conditions are secured by the orientation of the building (Eastwards). Front side's frames are made of aluminium, while these of the back side are made of wood. Balconies are covered by awnings. There is a flat roof and the dominant materials of the building are cement and aluminium.

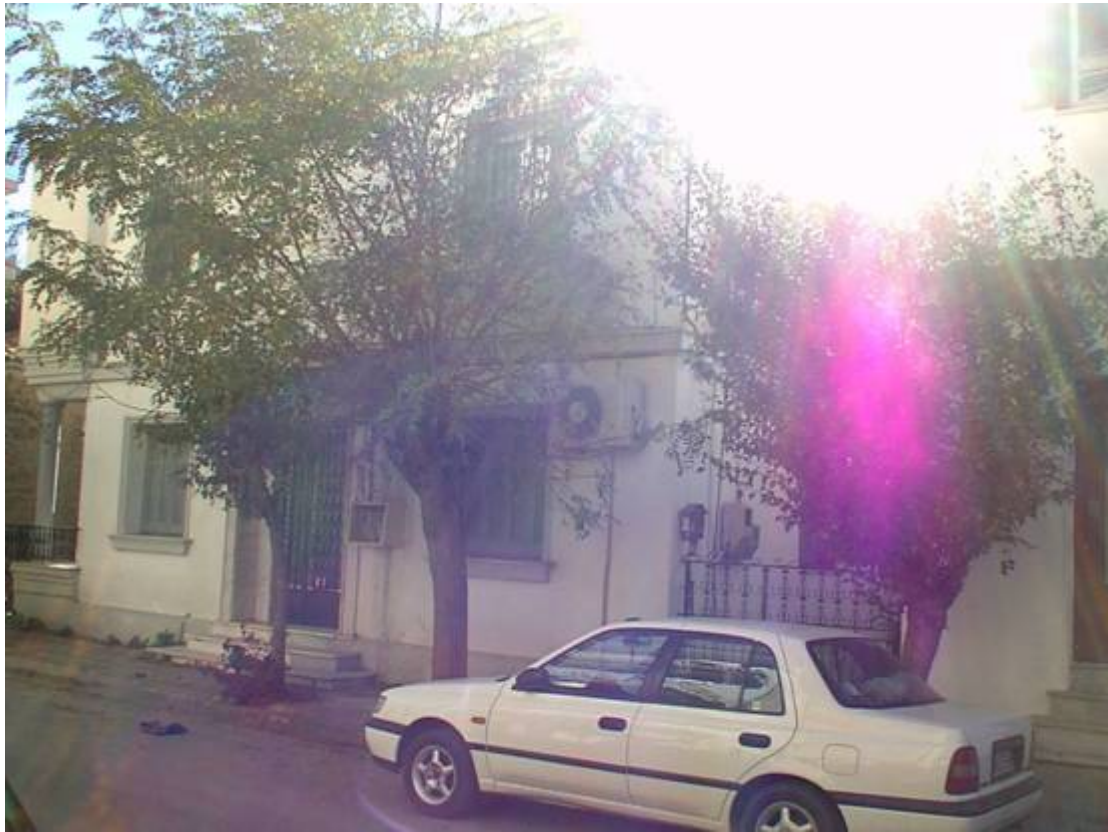
3.4. Building No4

This is a single storey house. This is one of the older constructions of our sample, since it was constructed on 1958. It consists of 3 apartments that comprise a total dwelling surface of 180 m². As a total 4 people live in this building.

Electricity is used for heating. More specifically, they only use electric radiators. This building is not supplied with natural gas. For heating water they use electric water heaters.

Cooling is obtained with the use of air conditioners. It is noticeable that we have counted 7 air conditioners for 3 apartments, in overall. The orientation of the building is eastwards - southwards. Frames are made of aluminium or wood. There is a tiles roof and the dominant material of the building is cement.

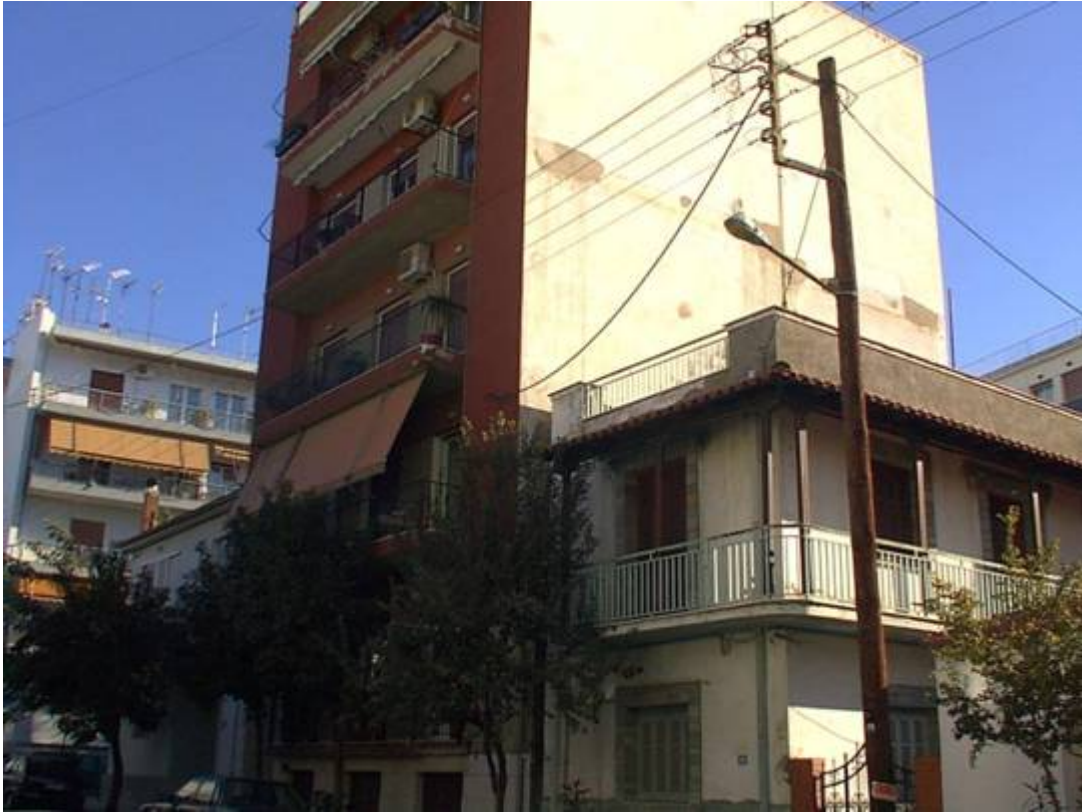
3.5. Building No5

This is a 4 storey building with basement. It consists of 5 apartments. The building was constructed on 1977.

The fuel used for heating is oil and the mean yearly consumption is 4,5 tons, which means we have a consumption rate of 8,9 lit/m²/year. The oil burner is being maintained every year, on September. This building is not supplied with natural gas. For heating water they use water heaters, electric or solar.

In most apartments cooling is obtained with air conditioners. Good lighting conditions are secured by the orientation of the building (Eastwards - Westwards). Frames are made of wood. Balconies of the west side are covered by awnings. There is a flat roof and the dominant material of the building is cement.

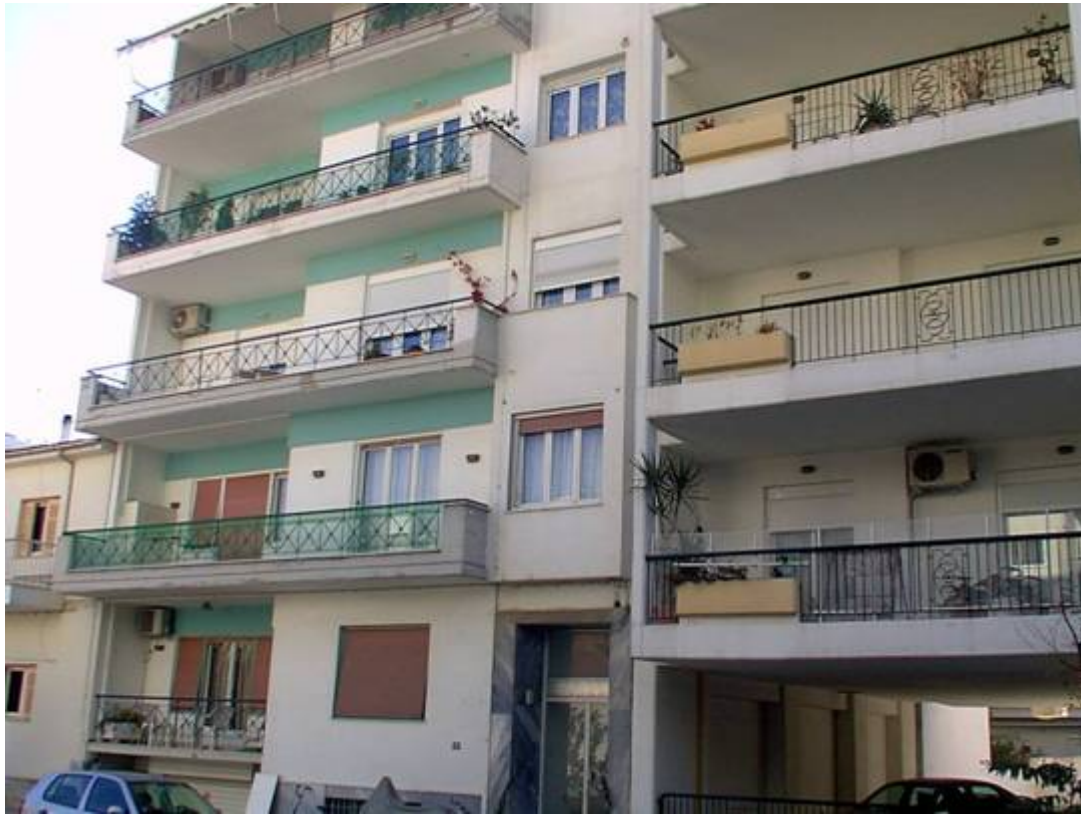
3.6. Building No6

This is a 4 storey building. It consists of 8 apartments that vary in size (from a studio of 28m² to a big apartment of 126m²). As a total 19 people live in this block of flats. The building was constructed on 1974.

The fuel used for heating till last year was oil. In two cases boiler systems were used for heating water and moreover one of these apartments spears a solar water heater. The rest apartments spare electric water heaters. There is a supply of natural gas starting form this year.

In some apartments cooling is obtained with air conditioners. We have a medium percentage of air conditioners per apartment in this block of flats (50%). Good lighting conditions are secured by the orientation of the building (Southwest – Northeast). Frames are made of wood in ground floor and first floor, while the above floors have aluminium frames. There is a flat roof and the dominant material of the building is cement.

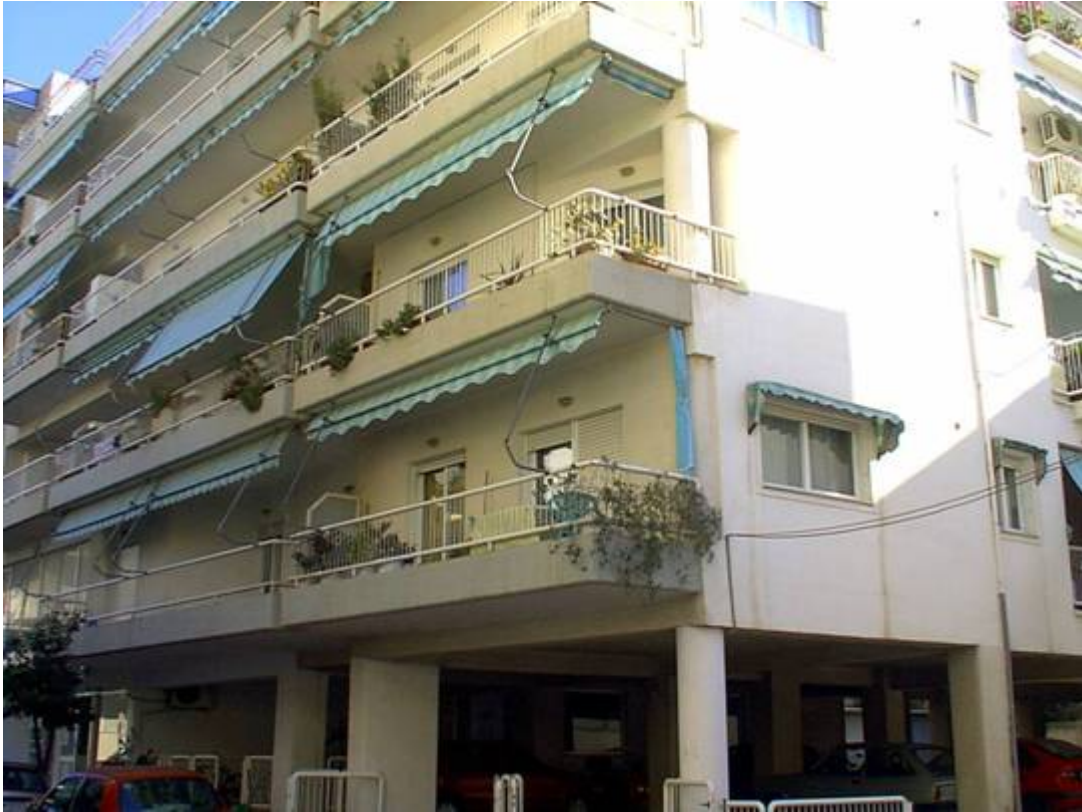
3.7. Building No7

This is a 6 storey stilted building. It consists of 25 apartments. As a total 70 people live in this block of flats. The building was constructed on 1990.

The fuel used for heating is oil and the mean yearly consumption is 24 tons, which means we have a big consumption rate of 13,6 lit/m²/year. The oil burner is being maintained every year, on May. This building is not supplied with natural gas. For heating water it spares a boiler system.

In some apartments cooling is obtained with air conditioners. The orientation of the building is westward. Frames are made of aluminium. All balconies are covered by awnings. There is a flat roof and the dominant materials of the building are cement and aluminium.

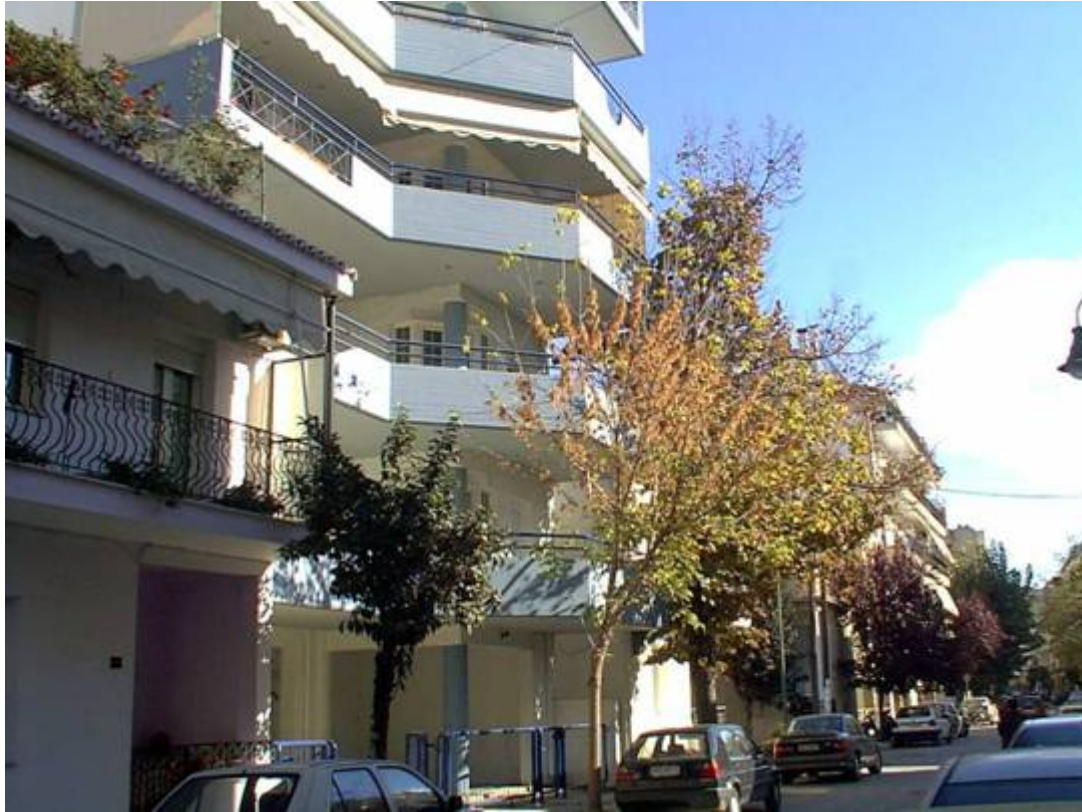
3.8. Building No8

This is a 4 storey stilted building. It consists of 3 apartments, 95m² each. The building was constructed on 1995.

This building has been just connected with natural gas. It also spares a boiler system for hot water.

Cooling is obtained with air conditioners. The orientation of the building is eastwards and southwards. Frames are made of PVC. There is a flat roof and the dominant material of the building is cement.

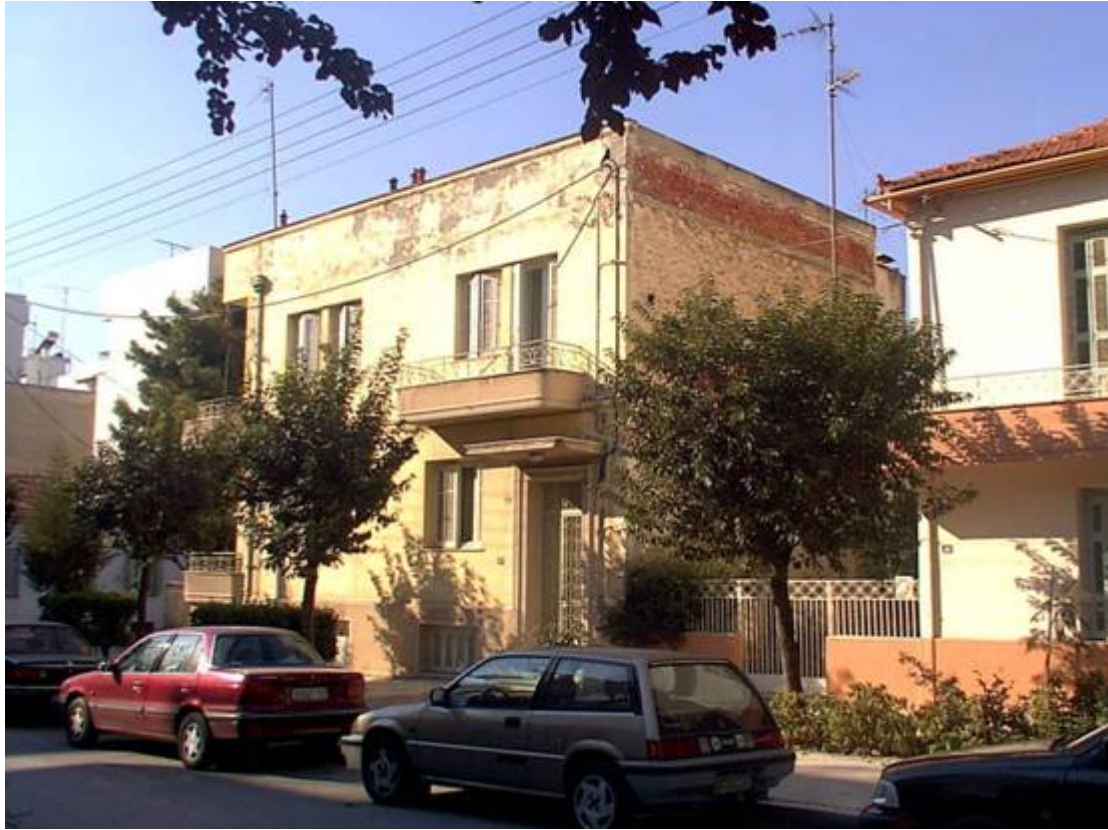
3.9. Building No9

This single storey house is the oldest constructions of our sample, since it was constructed on 1953. It consists of 2 apartments that comprise a total dwelling surface of 280 m². As a total 5 people live in this building.

Electricity is used for heating. More specifically, they only use electric radiators. This building is not supplied with natural gas. For heating water they use electric water heaters.

Cooling is obtained with the use of 2 air conditioners. The orientation of the building is eastwards - westwards. There are no awnings. Frames are made of wood. There is a tiles roof and the dominant material of the building is cement.

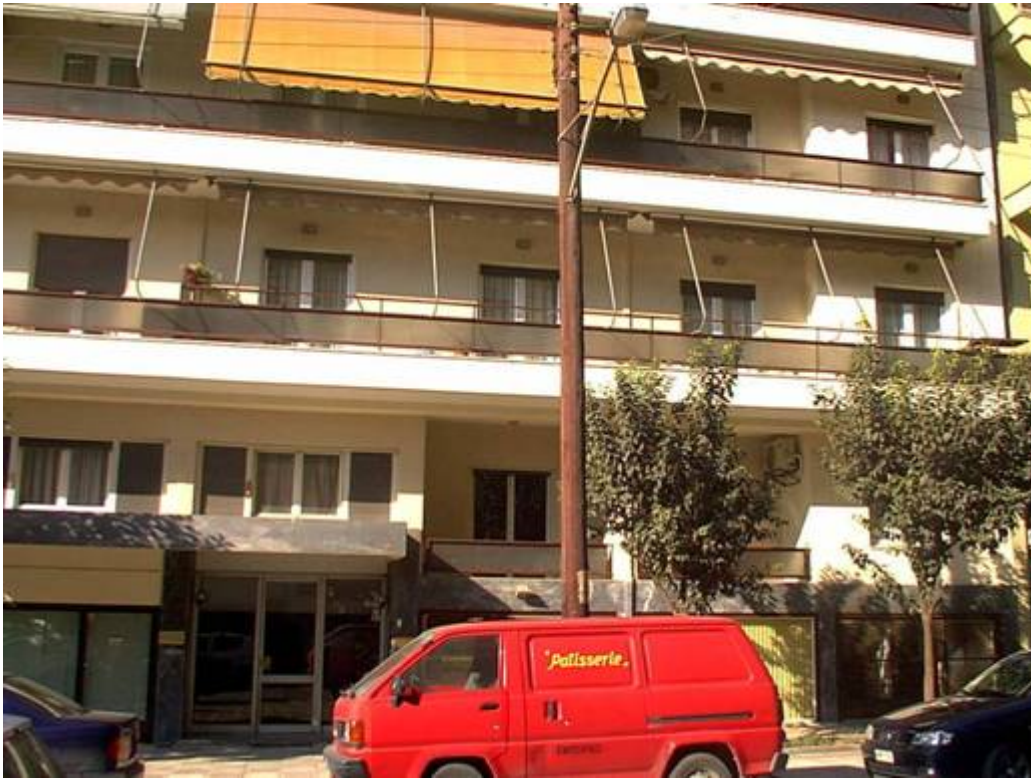
3.10. Building No10

This is a 5 storey building with stores on the ground floor. It consists of 17 apartments. As a total 55 people live in this building. The building was constructed on 1978.

The fuel used for heating is oil and the mean yearly consumption is 13 tons, which means we have a consumption rate of 10,04 lit/m²/year. The oil burner is being maintained every year, on September. This building is not connected with natural gas, though there is a supply. For heating water they use water heaters, mostly electric (there are only 2 solar water heaters).

Some apartments spare air conditioners. Good lighting conditions are secured by the Eastward orientation of the building. Frames are made of wood and aluminium. Balconies are covered by awnings. There is a flat roof and the dominant material of the building is cement.

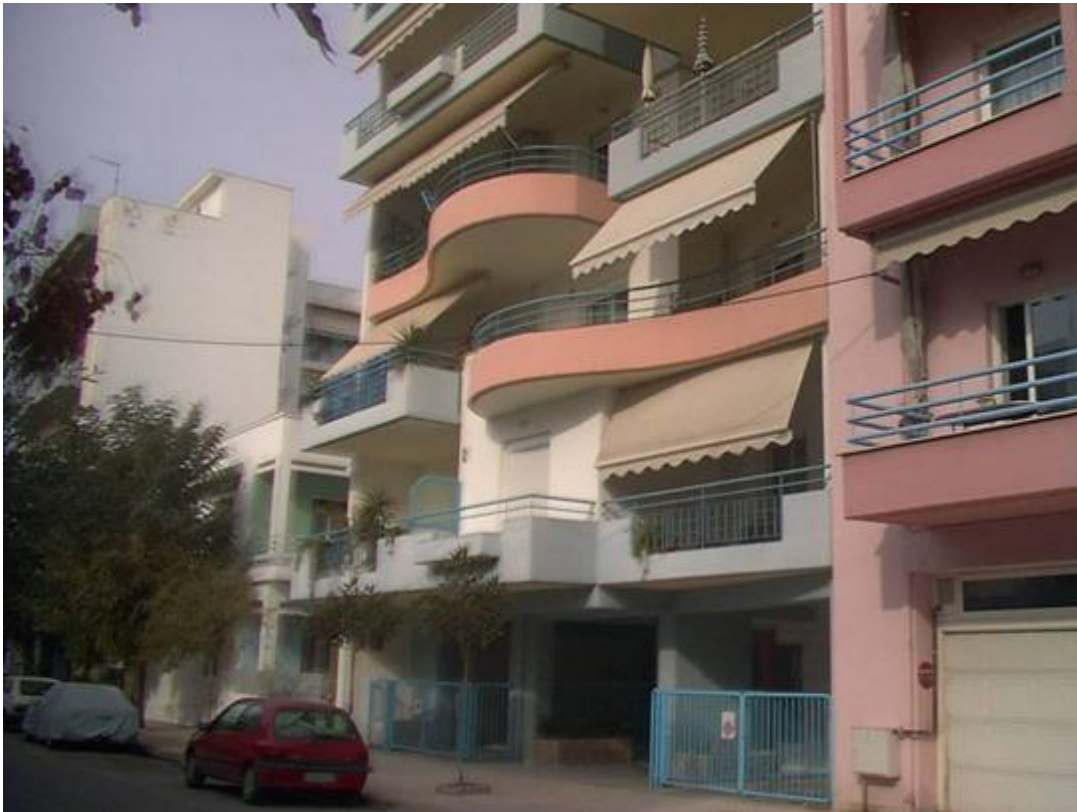
3.11. Building No11

This is a 5 storey stilted building. It consists of 11 apartments. As a total 40 people live in this building. The building was constructed on 1995.

This building is connected with natural gas. This is the only case in our sample that we have data on natural gas consumption, because the gas supply started one year ago. The mean yearly consumption in this building is 12.600 m³. This means we have a consumption rate of 12,3 m³/m²/year. The gas burner is being maintained every year, on May. The building spares a boiler system for hot water and moreover we have record 6 solar water heaters.

In the majority of the apartments cooling is obtained with air conditioners. The orientation of the building is eastwards and southwards. Frames are made of aluminium. There is a flat roof and the dominant materials of the building are cement and aluminium.

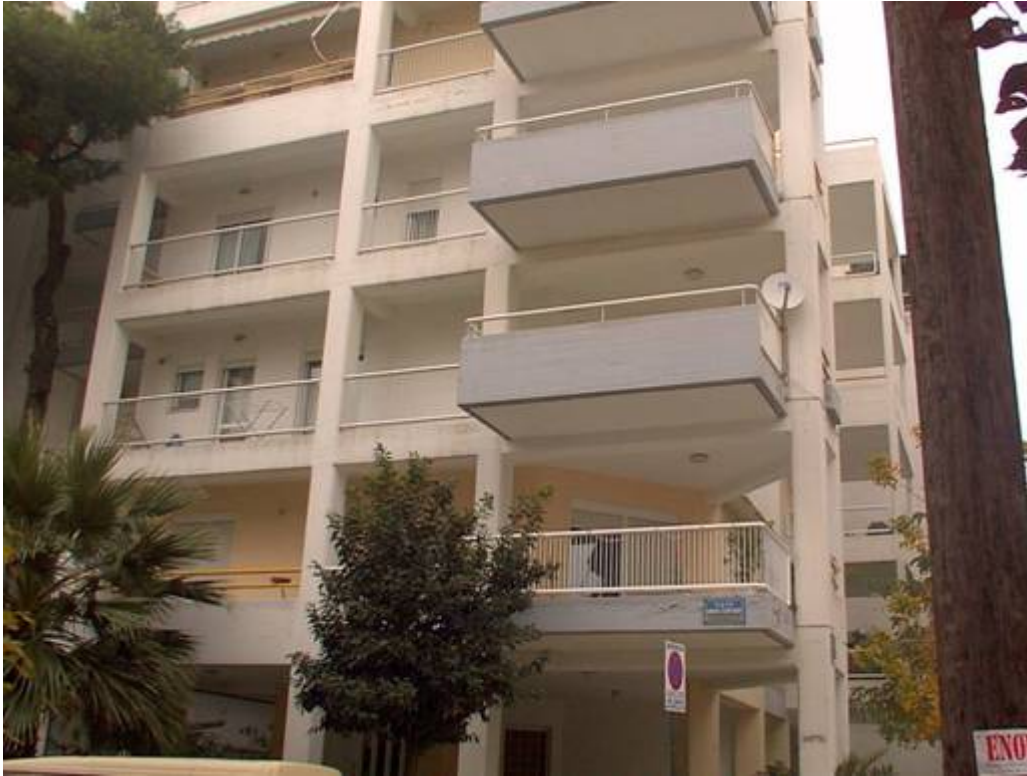
3.12. Building No12

This is a 6 storey stilted building. It consists of 11 apartments. The building was constructed on 1993.

This building has been just connected with natural gas. It also spares a boiler system for hot water.

Cooling is obtained with air conditioners. The orientation of the building is eastwards. Frames are made of aluminium. There is a flat roof and the dominant material of the building is cement.

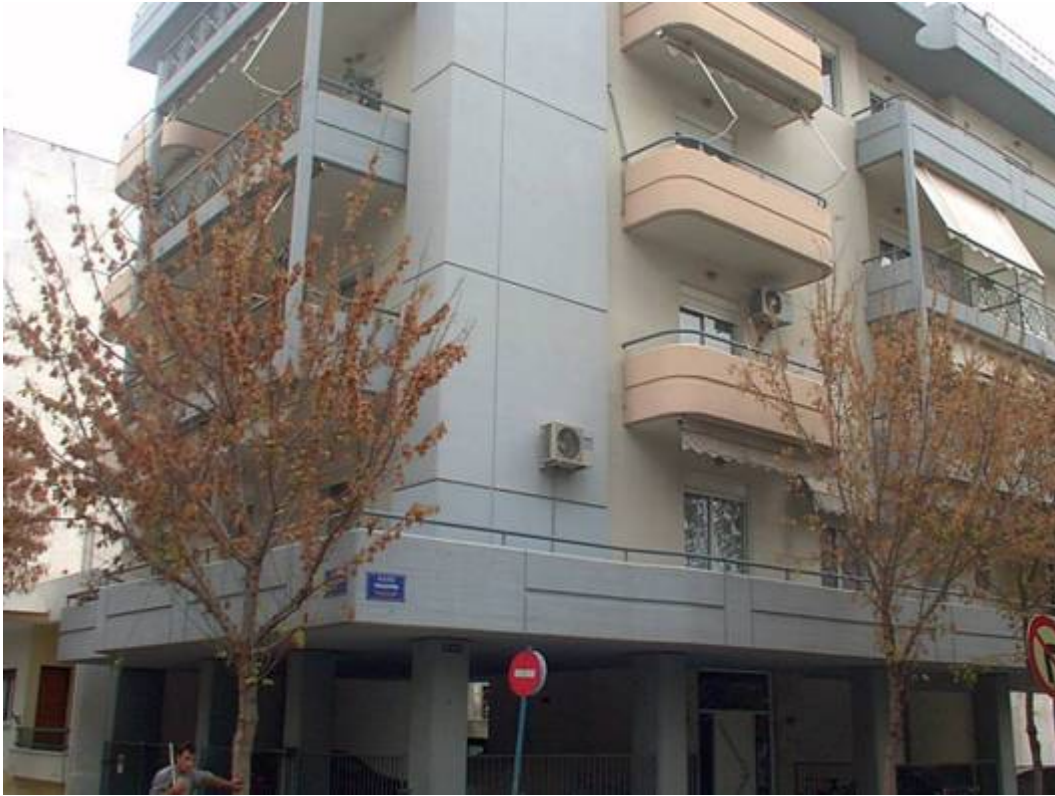
3.13. Building No13

This is a 5 storey stilted building. It consists of 10 apartments. The building was constructed on 1994.

The fuel used for heating is oil. The oil burner is being maintained every year. This building is connected with natural gas this year. For heating water they use water heaters, mostly electric (there is only 1 solar water heater), while they also spare a boiler system.

In this block of flats, the half apartments spare air conditioners. Good lighting conditions are secured by the Eastward orientation of the building. Frames are made of aluminium. All balconies are covered by awnings. There is a flat roof and the dominant material of the building is cement.

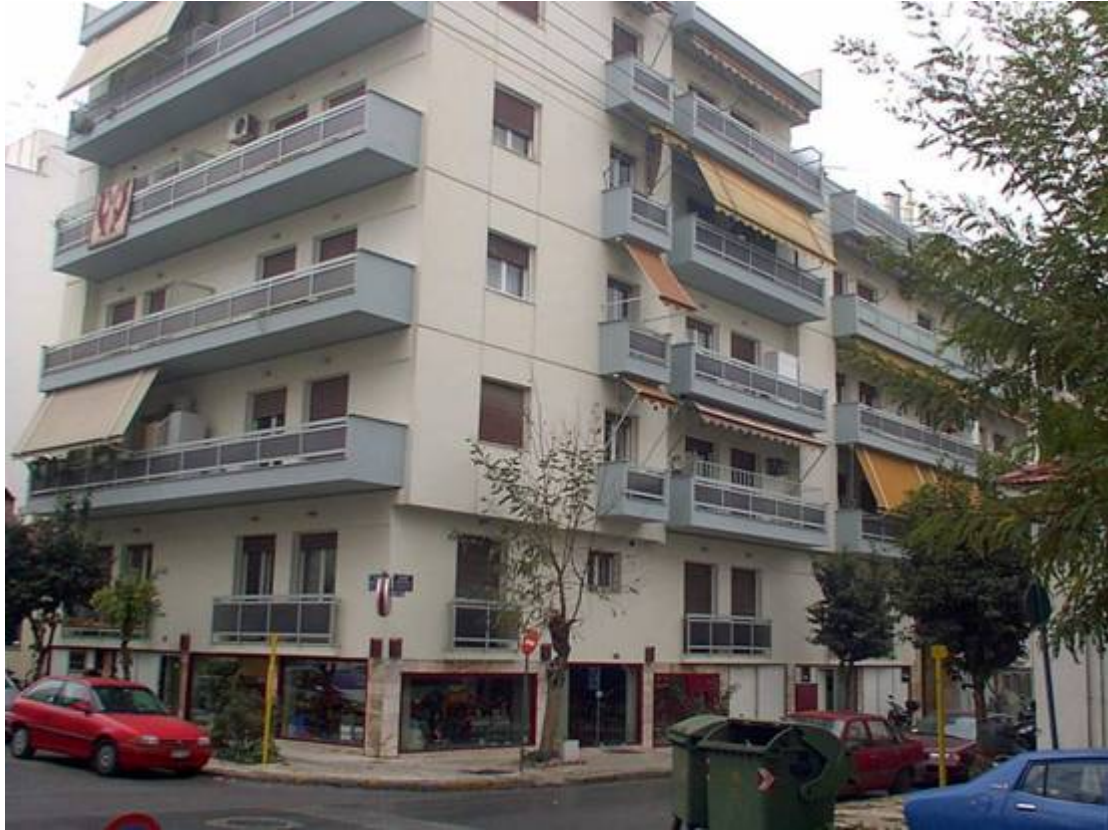
3.14. Building No14

This is a 4 storey building with stores on the ground floor. It consists of 26 apartments. The building was constructed on 1978.

The fuel used for heating is oil and the mean yearly consumption is 20 tons, which means we have a consumption rate of 10,92 lit/m²/year. The oil burner is being maintained every year, on May. This is not a supply of natural gas in this building. For heating water they use water heaters, mostly electric (there are only 3 solar water heaters).

Some apartments spare air conditioners. The orientation of the building is eastwards - westwards. Frames are made of wood. Most balconies are covered by awnings. There is a flat roof and the dominant material of the building is cement.

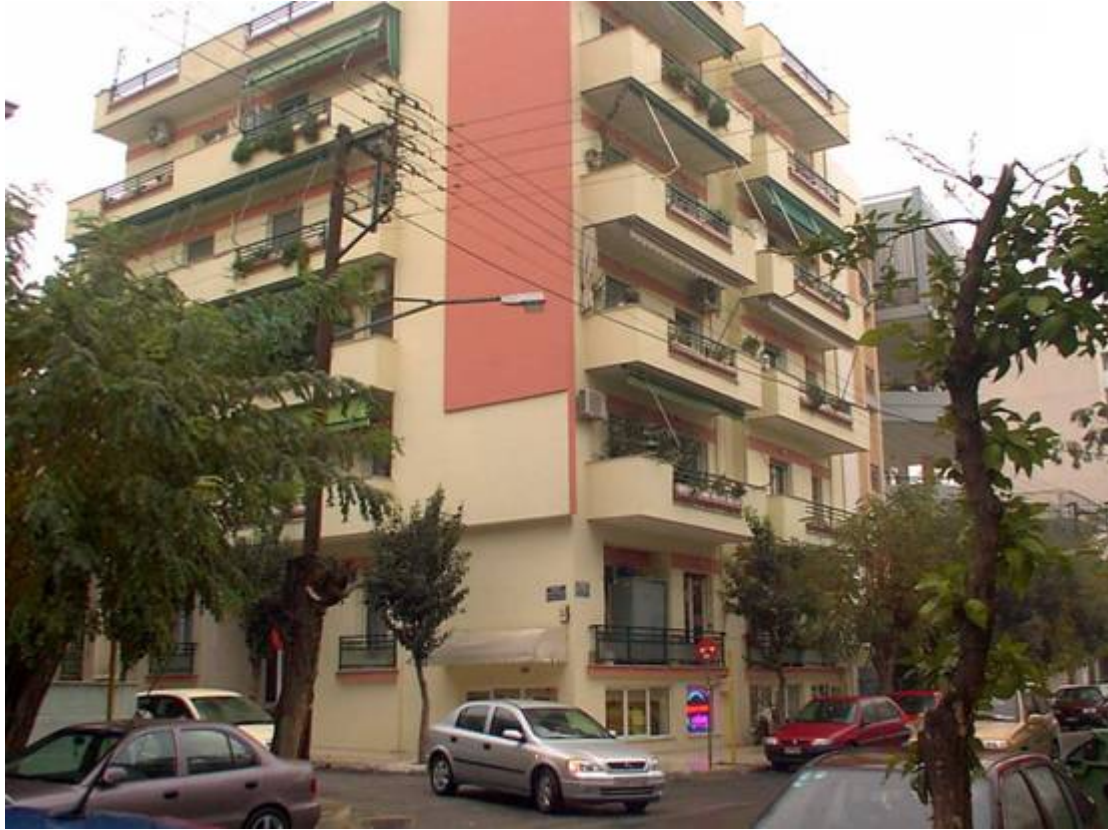
3.15. Building No15

This is a 4 storey building with stores on the ground floor and a basement. It consists of 13 apartments. The building was constructed on 1978.

The fuel used for heating is oil and the mean yearly consumption is 13 tons, which means we have a consumption rate of 12,67 lit/m²/year. The oil burner is being maintained every year, on September. This is not a supply of natural gas in this building. For heating water they use electric water heaters.

Some apartments spare air conditioners. The orientation of the building is eastwards - westwards. Frames are made of wood. Most balconies are covered by awnings. There is a flat roof and the dominant material of the building is cement.
